ATTACHMENT 8
Declaration of Joseph L. Shelnutt

**IN THE UNITED STATES DISTRICT COURT
FOR THE WESTERN DISTRICT OF TEXAS
AUSTIN DIVISION**

Declaration of Joseph L. Shelnutt

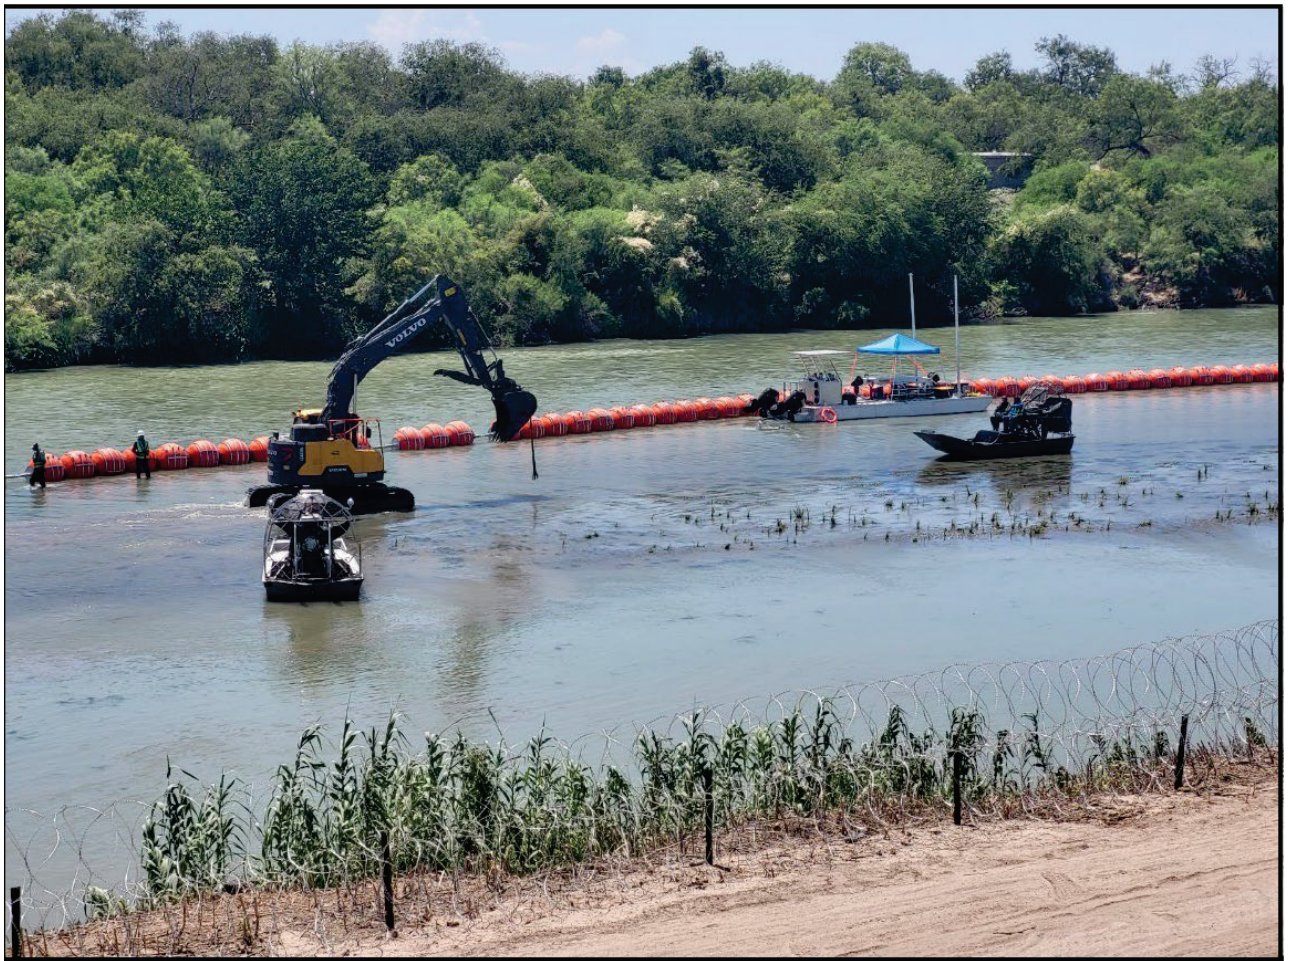
10. We located the site where the floating buoy barriers were being installed approximately 2.5 miles downstream of the staging area. From the bank, we observed orange spheres, with a four-to-six-foot diameter, being installed in shallow water of the Rio Grande with the use of

an excavator, supported by individuals standing on the riverbed, two airboats, and barge type watercraft. Around 450 feet of buoys had been installed. Although no cables or concrete blocks were observed at the time, the upstream portion of the installed buoys were stationary and were not held in place by equipment nor individuals and appeared to be anchored in place on the immediate riverbed. The approximate latitude and longitude of the work in the Rio Grande was 28.6709, -100.5030. We documented our observations with several photographs.

11. This is a photograph of the work on the floating barrier we witnessed during our site visit. I took the photograph:

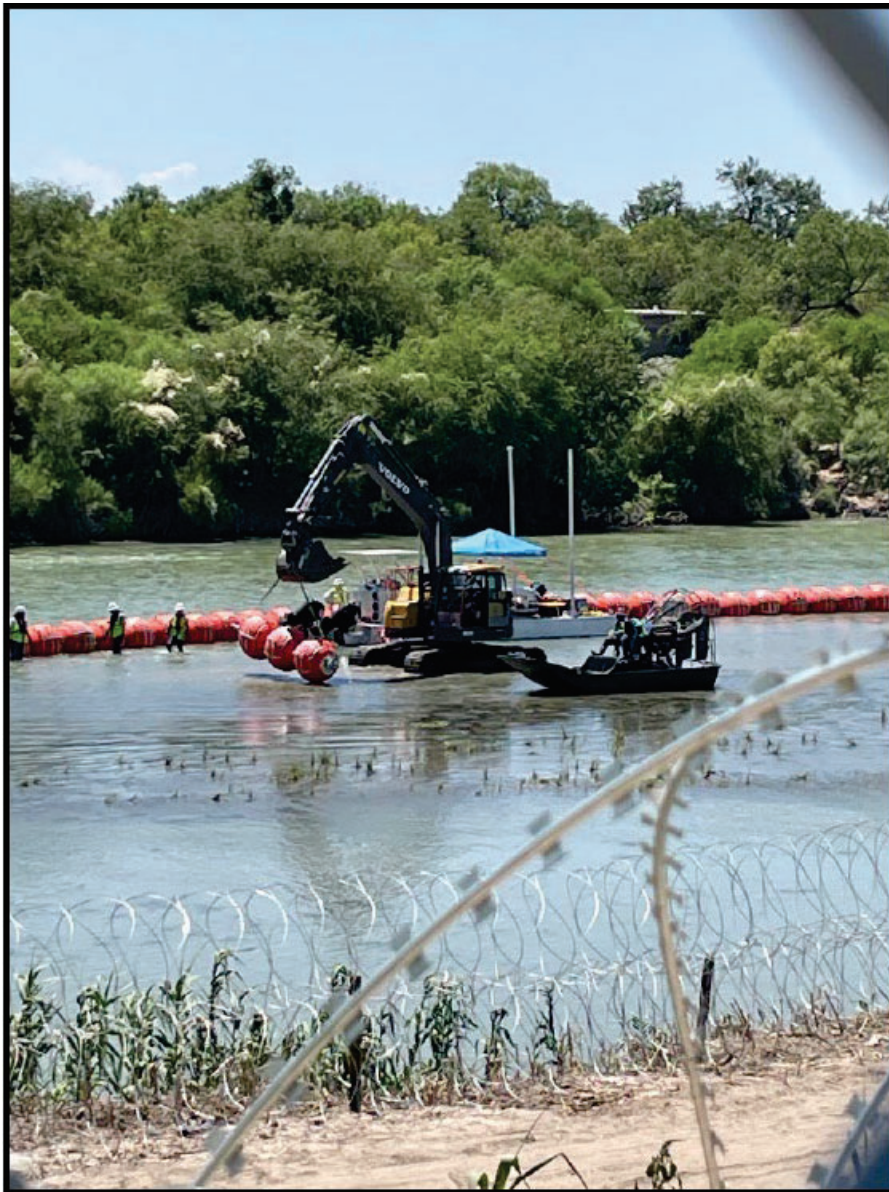
12. This is a photograph of the excavator working on installing the buoys that we witnessed during our site visit. Neil Lebsock took the photograph:
